# Paint Matters - Tips for Coating Galvanized Metal

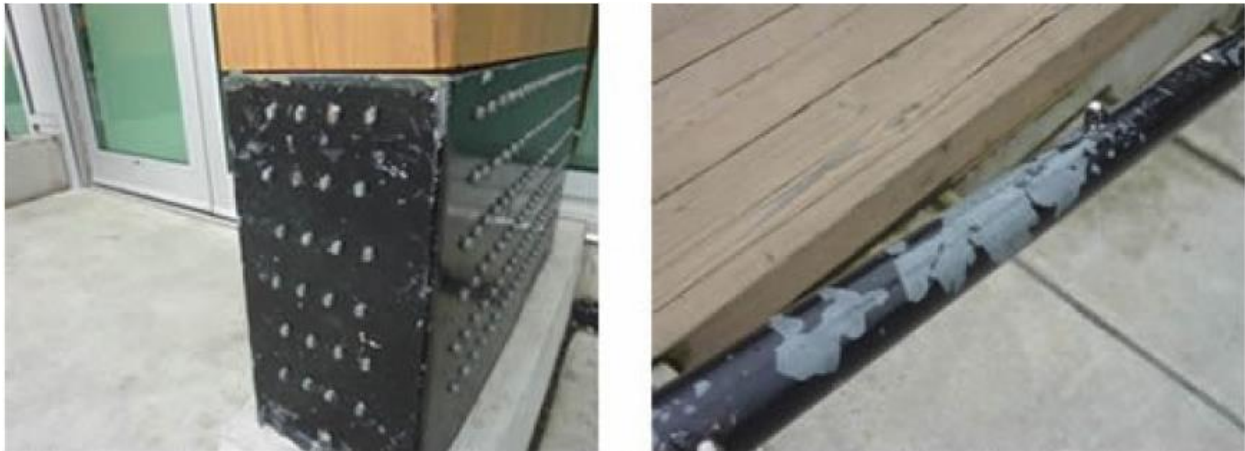
Chipping paint reveals neither primer nor surface preparation on underlying galvanized surfaces

After 5 years of service, some wear and tear (chalking, fading) of the topcoat can be expected, however the mall owner was not prepared to witness large pieces of paint peeling off and flaking down to bare metal.

Inspection revealed that no primer had been used before the high performance latex topcoat was applied.

Although the lack of priming may have contributed to the coating failure, further analysis found that a lack of surface preparation was likely the primary cause. By examining the surface, the inspector found that the galvanized metal was still shiny and smooth, indicating that no preparation was used to roughen the surface.

This failure could have been avoided if the newly-installed galvanized structures had been washed down with an etch primer (such as those listed under [MPI# 25](#)) to roughen and dull the surface, was allowed to dry for one day, and then primed with a waterbased acrylic primer ([MPI# 134](#)) before applying the high performance latex topcoat, allowing the topcoat to fulfill its expected service life.
