Failure of a decorative sculpture coating.

Inspection of applied paint finishes to 7 fiberglass sculptures.

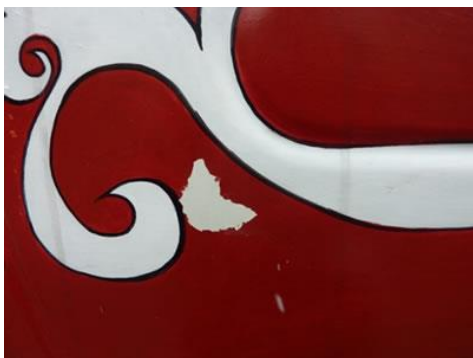
The paint finish was found to be in good condition. No fading or chalking was noted. There was a small patch found where the paint was removed down to the white primer. Some small nicks and scratches were found on the right side.

Small delaminated area down to primer

This sculpture should be monitored over the next few seasons to see if any further delamination occurs but as of today's date, adhesion of the remaining paint was found to be acceptable.

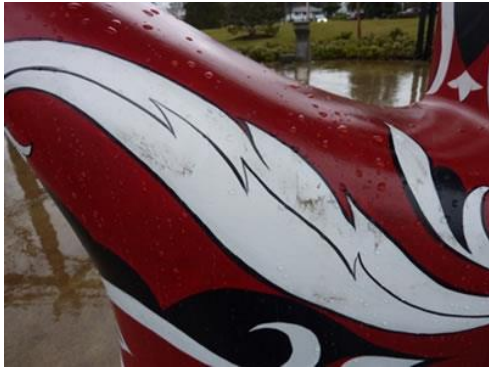
Scrapes and black marks on the side

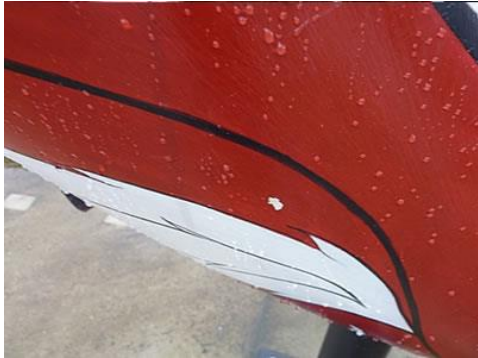
Small scrape in the finish down to the fiberglass primer

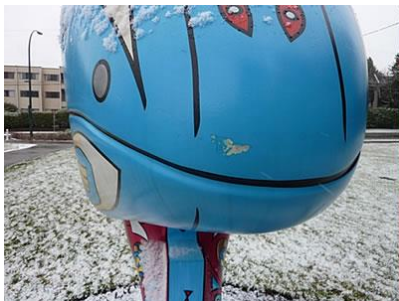
Sculpture 2

The paint finish was found to be in good condition. A small area was found to have impact damage. A long scratch, perhaps done by a key, was found under the head. Repairs would involve filling with a fiberglass filler and then touch-ups by the artist if possible.

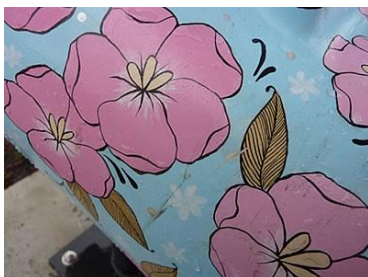
The paint finish was found to be in good condition. Other than a small scratch on the side of the tail, no significant damage or paint problems were found.

Small scratch in finish on side of tail

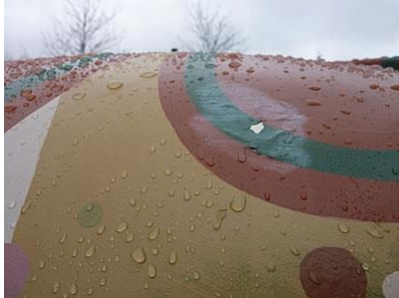
There was a significant size “blister” on the top left side of the sculpture. The blister was actually an area of coating (down to the primed fiberglass) that has allowed a little water under the film. The water then froze, expanding the paint film into a blister causing further delamination. The coating showed no signs of developing sufficient adhesion and could be peeled back easily. The adhesion of the entire layer of artist paint is questionable. Complete removal may be required.

Blister showing delamination of film

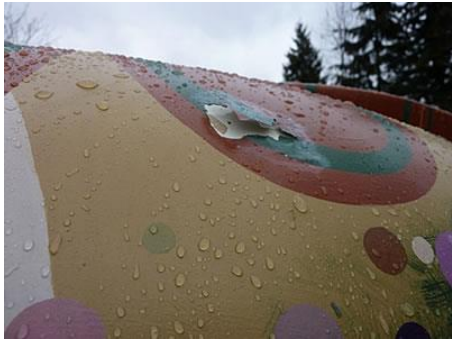
Blister broken and pulled back – no adhesion found

On the sculptures that had poor adhesion, the exposed primer was found to be quite shiny indicating that the surfaces had not been sanded prior to the application of the artist's paints.

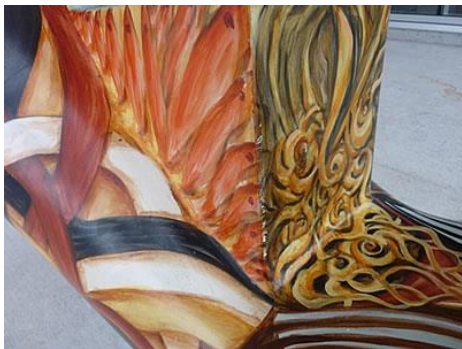
The paint finish on the sculpture was found to be in good condition. Some small scratches and abrasion found on the leading vertical edge of the sculpture.

Small scuffed areas, edge of sculpture

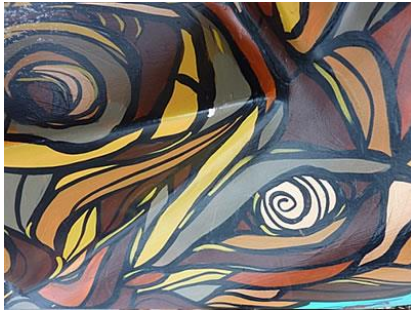
The paint finish was found to be in good condition. Small impact damage.

Very small impact damaged area

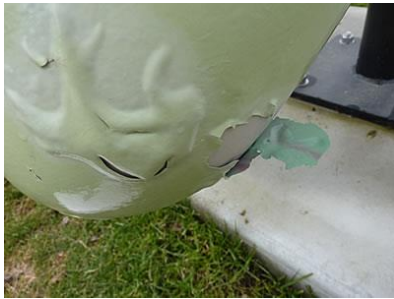
Adhesion of the applied artists finish was found to be questionable. At the base of the sculpture large multiple “blisters” were found. The blisters were the result of poor adhesion of the paint film that has let in a bit of water. The water then froze, expanding the paint film into a blister. Pulling back the blistered coating revealed that the coating has no adhesion and continued to peel back easily. The adhesion of the entire layer of artist finish is questionable. Complete removal may be required.

Base of sculpture - Large blisters

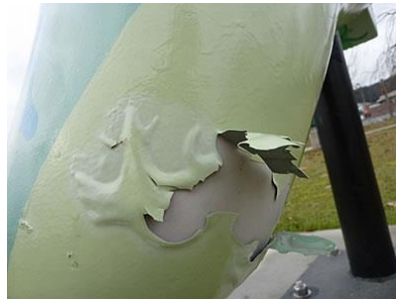
No adhesion of the surrounding paint finish

An industrial type exterior finish that incorporates Epoxy and / Polyurethane type finishes would have been the more appropriate types of finishes.
