What could cause a paint failure?

A site visit / inspection was carried out by a qualified inspector, the focus of the inspection was to check the adhesion of the previously painted exterior concrete tilt-up wall surfaces.

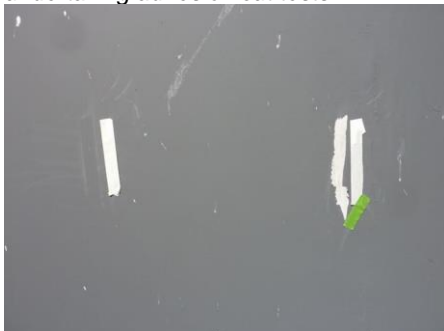
Adhesion cut tests were performed over a patched area and non-patched area at the same time.

- Adhesion cut tests over non-patched concrete revealed an adhesion level of "5A" = no peeling or removal. (Red arrow)
- Adhesion cut test on patched area: "0A" = no adhesion. Dust under the film. (Blue Arrow)

It became apparent that the coating on any patched and ground areas had no adhesion. The paint peeled easily back from the patches. The back of the peeled back coating revealed a large amount of concrete dust that was loose and had been painted over.

The result of the tests proved that the lack of adhesion on and around the patched areas was directly attributed to the amounts of loose concrete dust left on the surface before paint application. The dust should have been removed when the wall surfaces had been power washed, and the patched areas should have been checked for dust residue before any paint was applied.

1. *An area should be chosen as a mock-up.*
2. *Set up and power wash some sections of the dark concrete using high pressure and a turbo nozzle. Concentrate on the patched areas. This should remove any loose paint and any remaining concrete dust.*
3. *After, "feather edge" (power disc sand) the transitions between the bare patches and the remaining paint.*
4. *Spot prime all bare concrete with MPI #3 – W.B. Alkali Resistant Primer.*
5. *Topcoat the primed area with MPI #10 – Exterior Flat latex.*
6. *Finish coat entire area with MPI #10 – Exterior Flat Latex.*
