PAINT MATTERS

What Went Wrong?

They say we learn more from our mistakes, so we are publishing some educational advice in this edition of PaintMatters - letting you gain valuable experience at the expense of those who were left wondering 'What Went Wrong'.

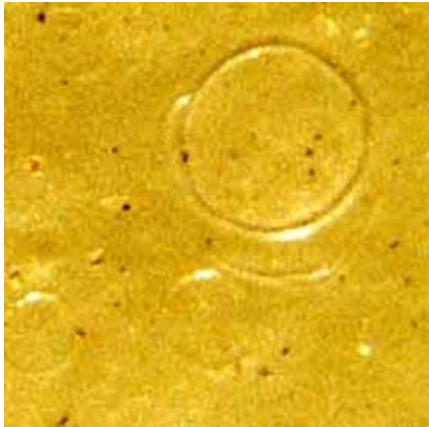
Military Tank Farm Failure

The government awarded a painting contract to clean and paint the exterior of a steel fuel tank on a remote military tank farm. Work was carried out in the summer. The apparent preparation work consisted of solvent cleaning to SSPC-SP1 and hand cleaning to SSPC-SP2. According to the information received, all work was carried out in accordance with the specifications. The contractor maintained that all cleaning and painting work was carried out within the environmental requirements.

Nevertheless within months, the paint coating was blistering and peeling.

A technical consultant was flown into the area to have a closer look. Although the contractor had assured all parties that the coating was applied in acceptable environmental conditions, a microscopic evaluation revealed pinholes and that moisture drops had lodged onto the paint film before the coating was dry, as is shown in this photograph.

What Went Wrong? - The conclusion was that insufficient preparation work had been done. Priming was done sparingly, and topcoat application varied from 1 to 2 mils dry film thickness. Sparingly prepared surfaces and applied coatings, in combination with wet surfaces at the time of the coating application led to the failure.

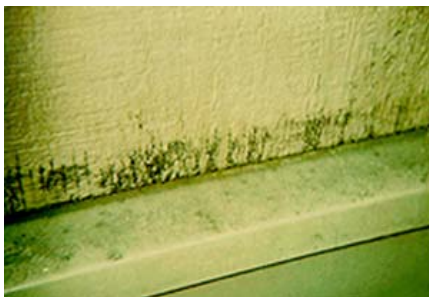
It's Not Always the Paint

In many instances, it is not the paint which lags in performance. All too often, the problem can be attributed to flaws in design or construction, or due to poor application procedures. This photograph is a good example.

Checking of the bottom part of the panels was in evidence within six months. Within eight months, mildew growth presented an unsightly appearance all around this specific building.

The top edge of the foundation wall is not sloped properly, therefore, water cannot run off freely. Because it is level (and in some cases back sloping), the water can accumulate before running off. The space left between the wall plywood panels and the top edge of the concrete foundation wall is not large enough to prevent back splashing onto the bottom edge of the plywood panels. In addition to this, the edges of the plywood panels did not receive any kind of coating to prevent moisture penetration.

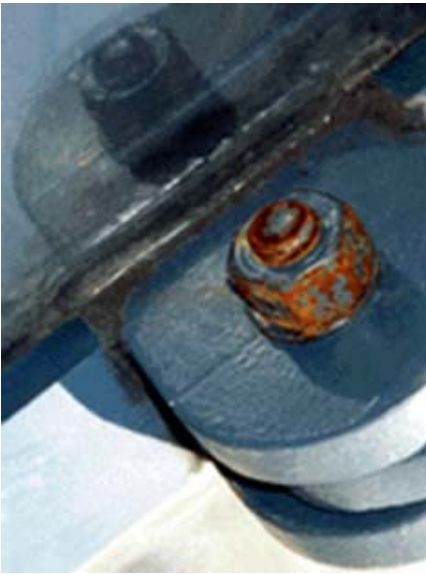
The Nuts and Bolts of Corrosion

In this situation, corrosion has appeared shortly after construction of this building on the angle bracket supports holding an exterior awning.

First, the coating has been damaged by the re-torquing of the bolts after painting. Apparently, no following touch-up work was performed or requested in these areas.

The second problem is that there was no primer applied to the bolts before top coating. In other areas that had not been re-tightened or had the paint damaged, there was some evidence of corrosion forming under the film and leaving oxide streaks on the lower painted surface. These areas would be expected to fail within one year and require grinding, priming and re-finishing - or replacement if the damage was too extensive.
