Paint Inspections Matter

June 2025

Newsletter: Painting Concrete with Fly Ash in the Mixture

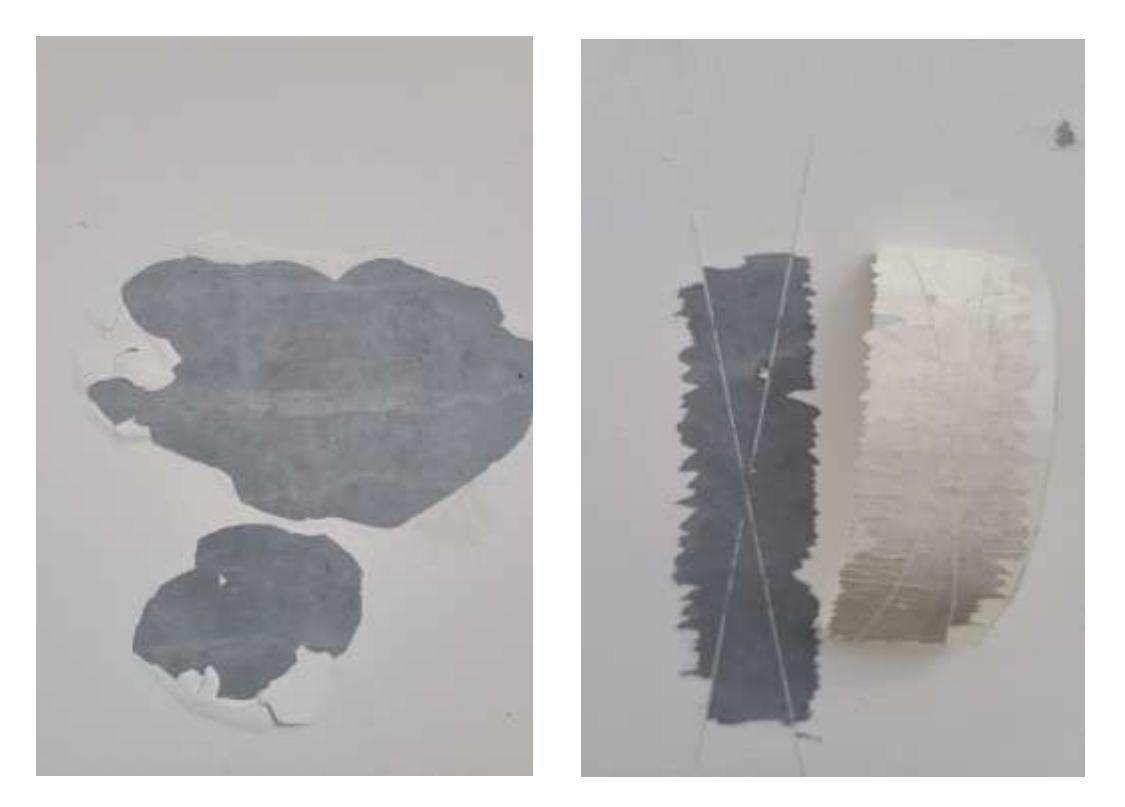
Over the last few years, we have encountered projects that were painted as above but then they experienced severe adhesion issues, with almost complete failure, as seen below.

Naturally we need to be wary of mould release agents that will impair adhesion, but we also must be aware of concrete that has a fly ash additive.

As stated earlier, one of the most significant issues when painting concrete that has fly ash in the mixture with latex paint is adhesion. Fly ash can create a smoother, denser, non-porous surface, which can make it harder for latex paint to properly bond. As Fly Ash is a byproduct of coal, it creates an oily residue in the concrete affecting adhesion.

We have found here and across North America, the best primers on this surface are oil-based primers, such as MPI #69, oil-based bonding primer.

We recommend that on all Cast in Place or Tilt up Concrete Panel jobs the following due diligence should be performed.

- 1. Ask the question, is there Fly Ash in the concrete mix. The concrete spec may say, or the GC may know.
- 2. Pour/spray water onto the concrete panel and check for water penetration. If it runs down the wall and does not penetrate then there is something making the surface nonporous. It could be a mould release agent OR Fly Ash OR both.
- 3. Do a "Mock Up" area. Apply the specified primer/paint system (probably a MPI #3, water-based primer and a sample of a MPI #69, oil-based bonding primer).
- 4. Allow to dry for a least 1 week and perform the ASTM D3359-09E adhesion test (tape and X cut).
- 5. Test for results.
