Caulking Wood Siding and Trims

Failed Caulking On Wood Siding

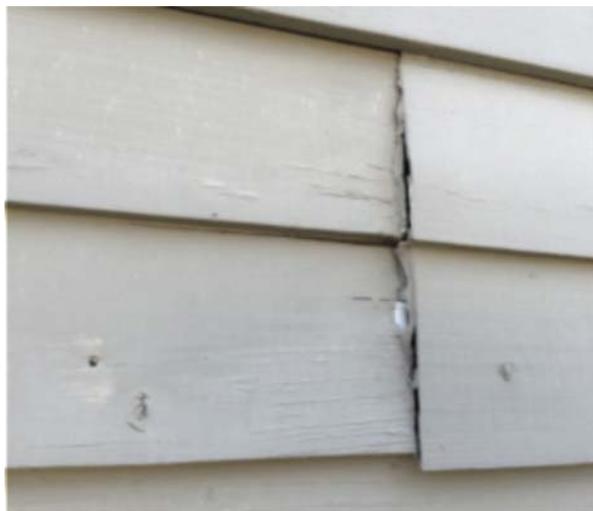
Caulking is not recommended for use on butt-joints on wood siding, as siding boards are designed to expand and contract with the elements in ways that the caulking cannot. For example, when heated in the sunlight the wood siding will expand both sideways and outwards.

This was a problem found during an inspection of painting preparation work on a recent repaint project. There was evidence of the caulking failing between all of the butt joints (see image above). The use of caulking was an attempt to correct other issues with the building, however, the caulking failed causing moisture to become trapped behind it resulting in wood rot and failure of both the coating and the caulking.

Caulking should be used sparingly on any external wood siding projects, and as seen in the inspection described above, and not on wood butt-joints because of the expansion and contraction in the elements.

The caulking was used in an attempt to correct other issues, but it failed and offered no protection resulting in the costly requirement of having to replace all of the deteriorated wood siding and trim.
